# Manhole Inspection Summary

Manhole # S41KK\_008MH

Insp Date: **6/9/09 10:34 AM**

**Location** Address: **1515 LAFAYETTE AVE**

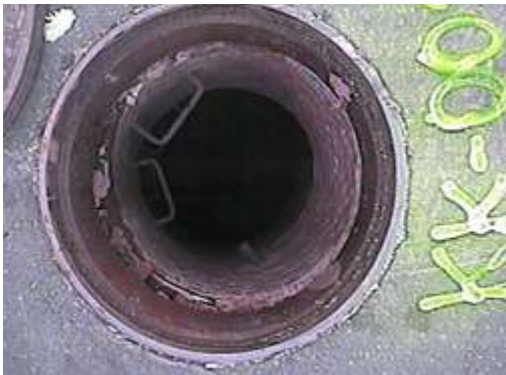
Defect 3

Offset: **1** (in.)

frame offset

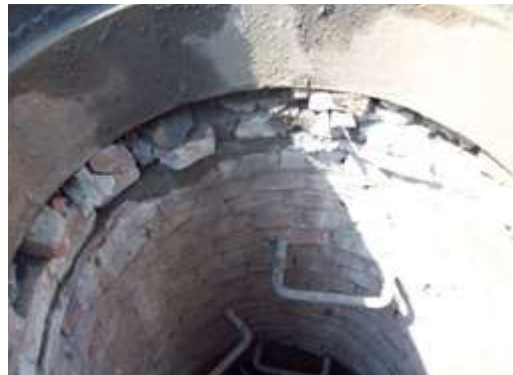
Defect 2

Condition: ☐ Sound ☐ Cracked ☐ Root Intrusion ☒ **Loose Brick** ☒ **Deteriorated**

Loose bricks

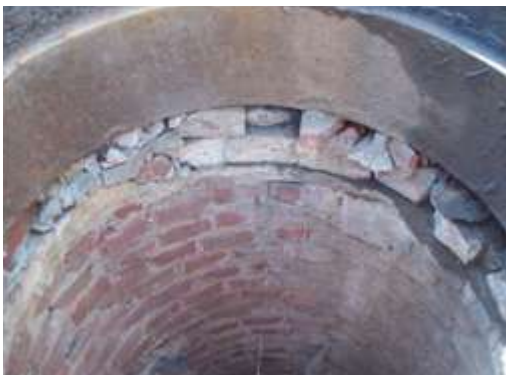
Defect 1

☒ Exists Material: **Brick and Concrete** ☐ Parged Height: **4** (in.)

Deteriorated chimney
